The following document is a compilation of the existing conditions of the South Hunterdon Regional School District Facilities – Lambertville Public School and West Amwell Township Elementary School.

FACILITY OBSERVATIONS OF
West Amwell Township Elementary School
+ Lambertville Elementary School
SOUTH HUNTERDON REGIONAL SCHOOL DISTRICT

Date: 10.2.2019

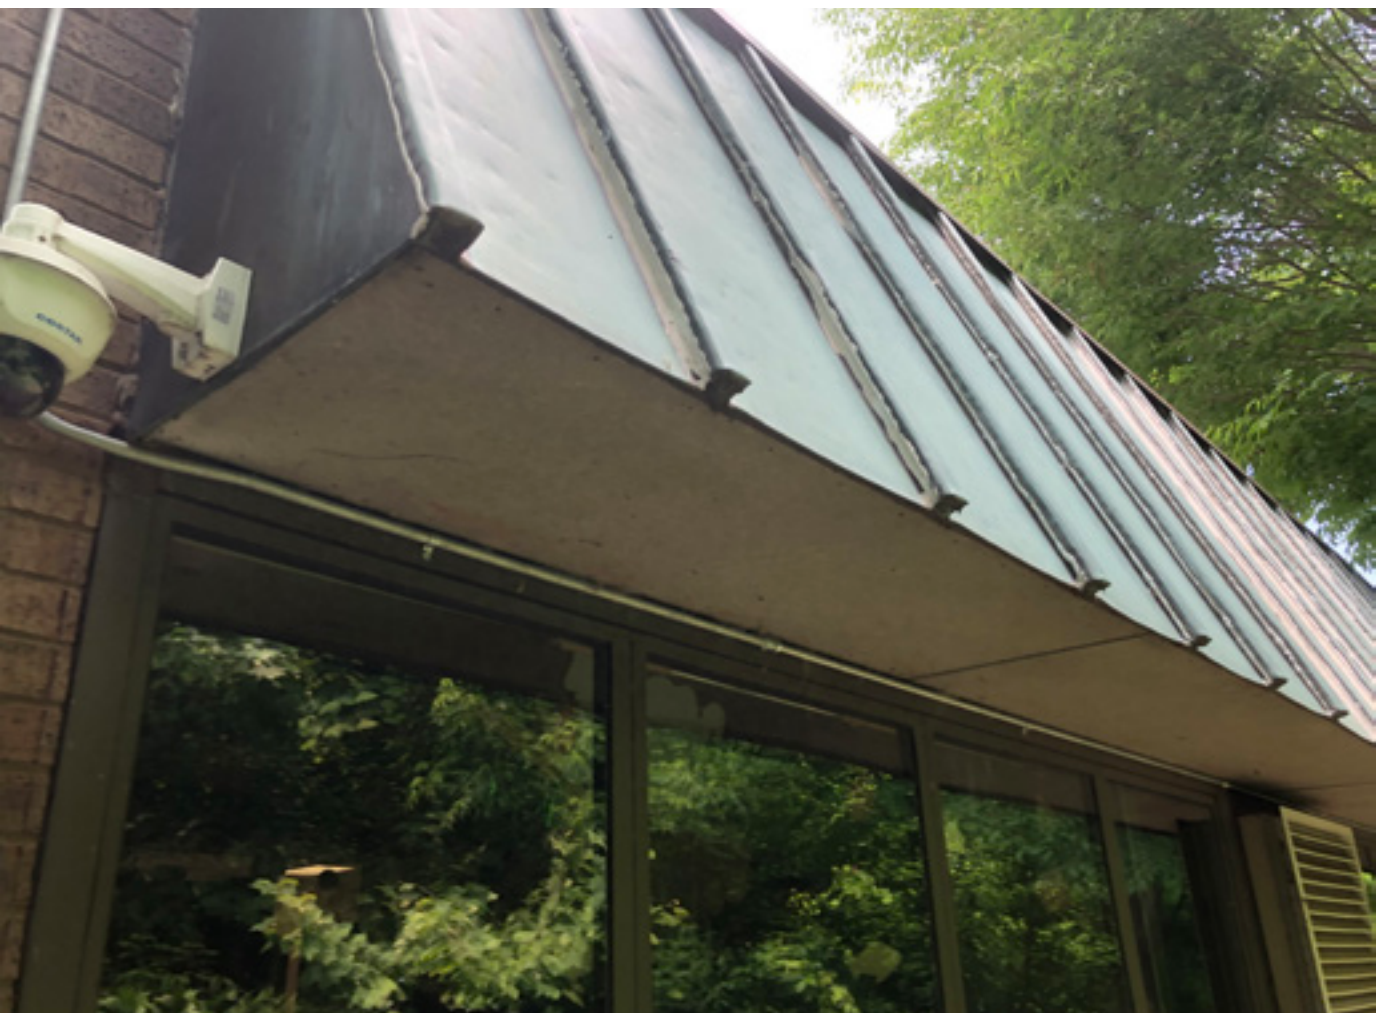
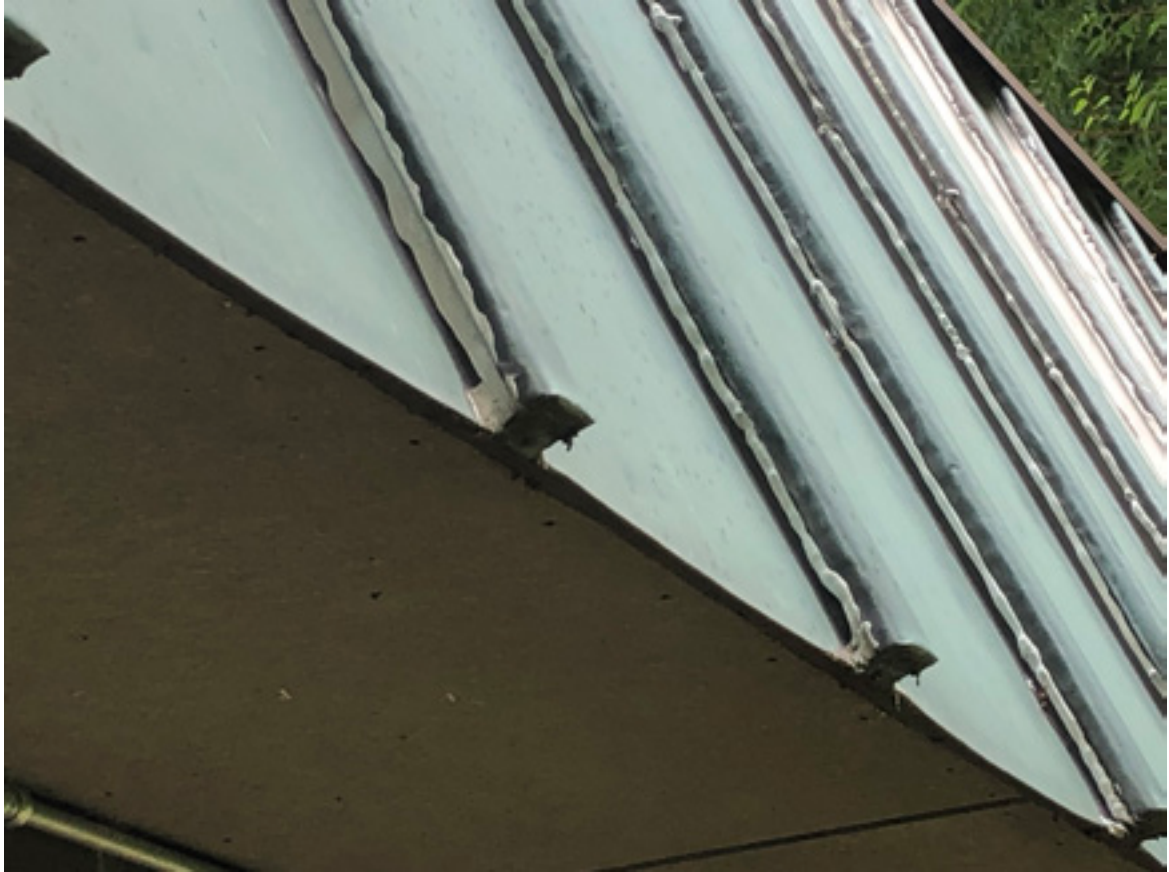
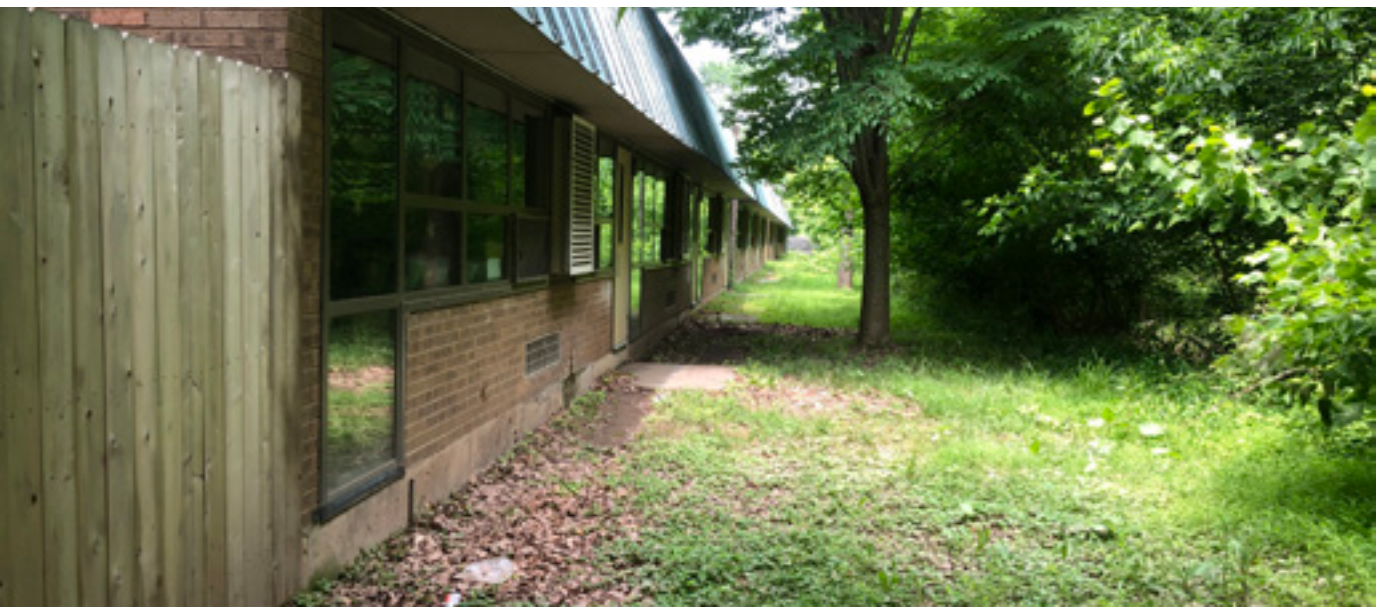
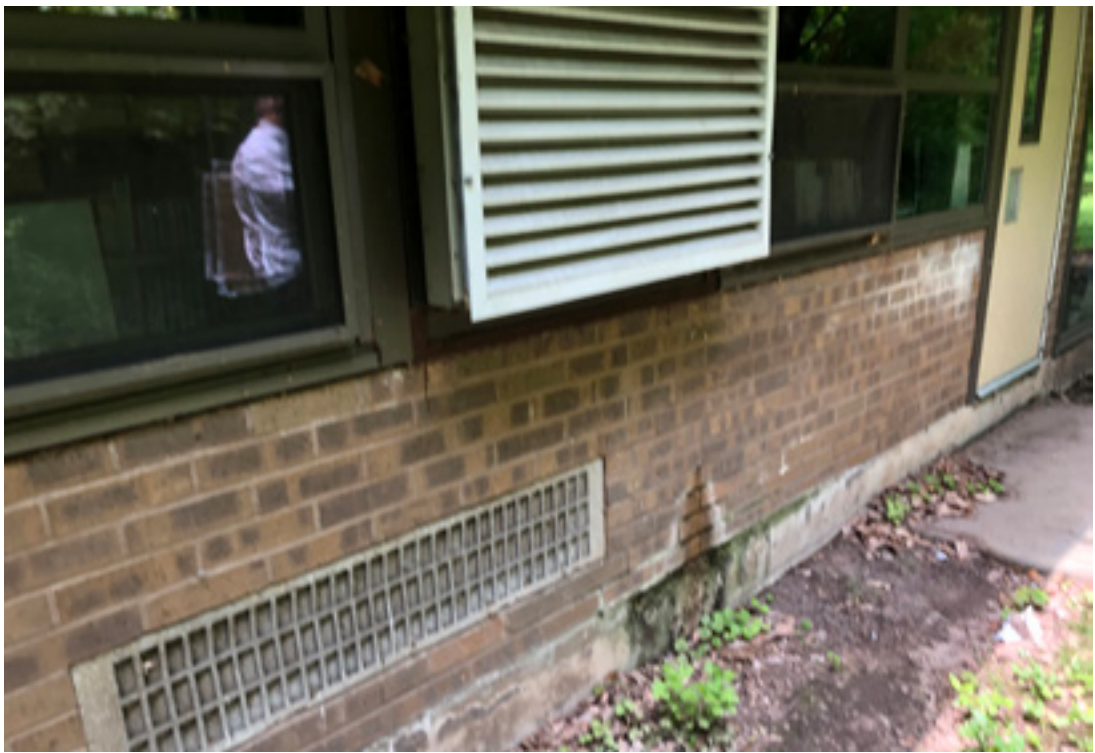
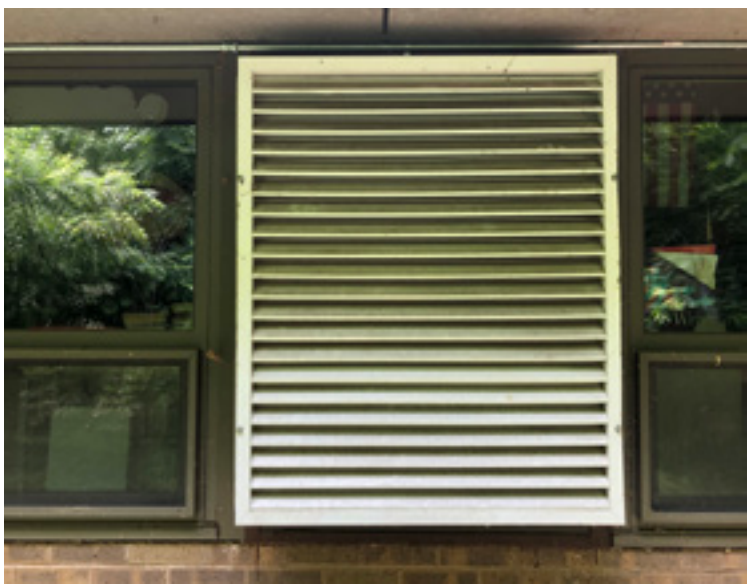
FACADE CONDITIONS

In general, Lambertville Public School core and shell is in good condition. The facility cannot be expanded nor can an upper level be added to the building. The facility's interior is lacking ADA requirements which creates a host of challenges with any reconstruction project. The facility is aging and in need of restoration.

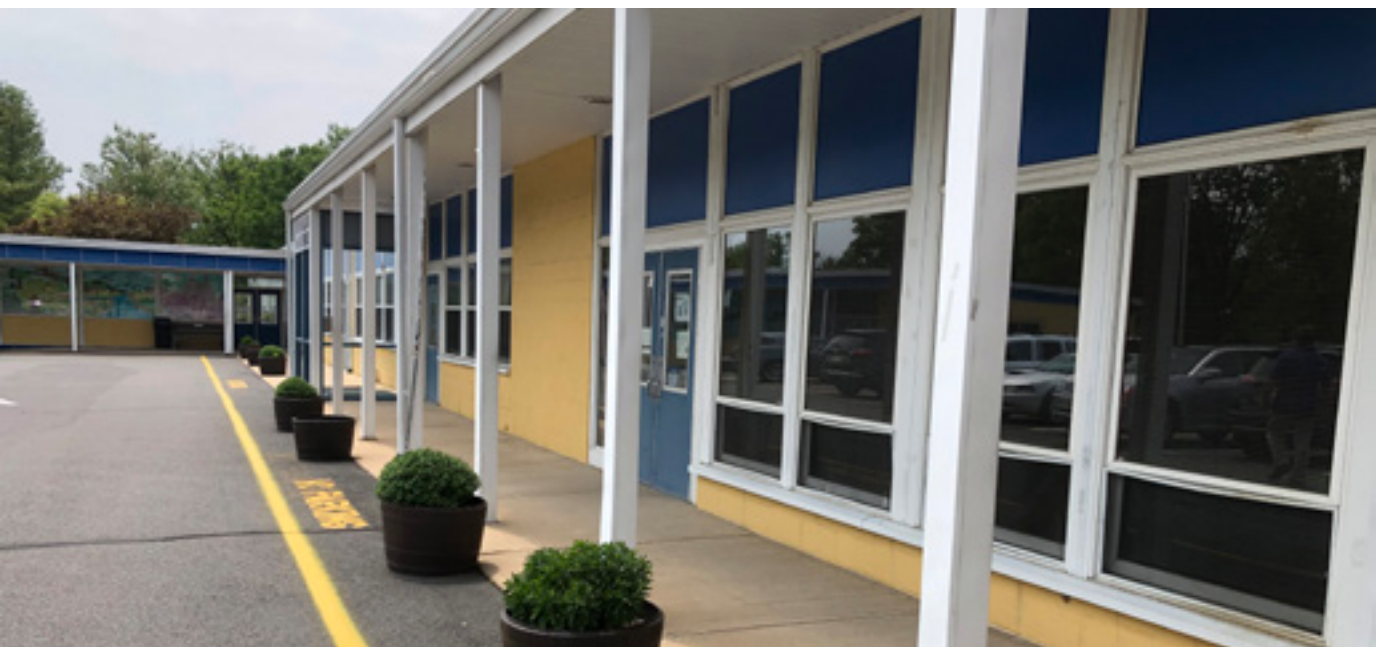
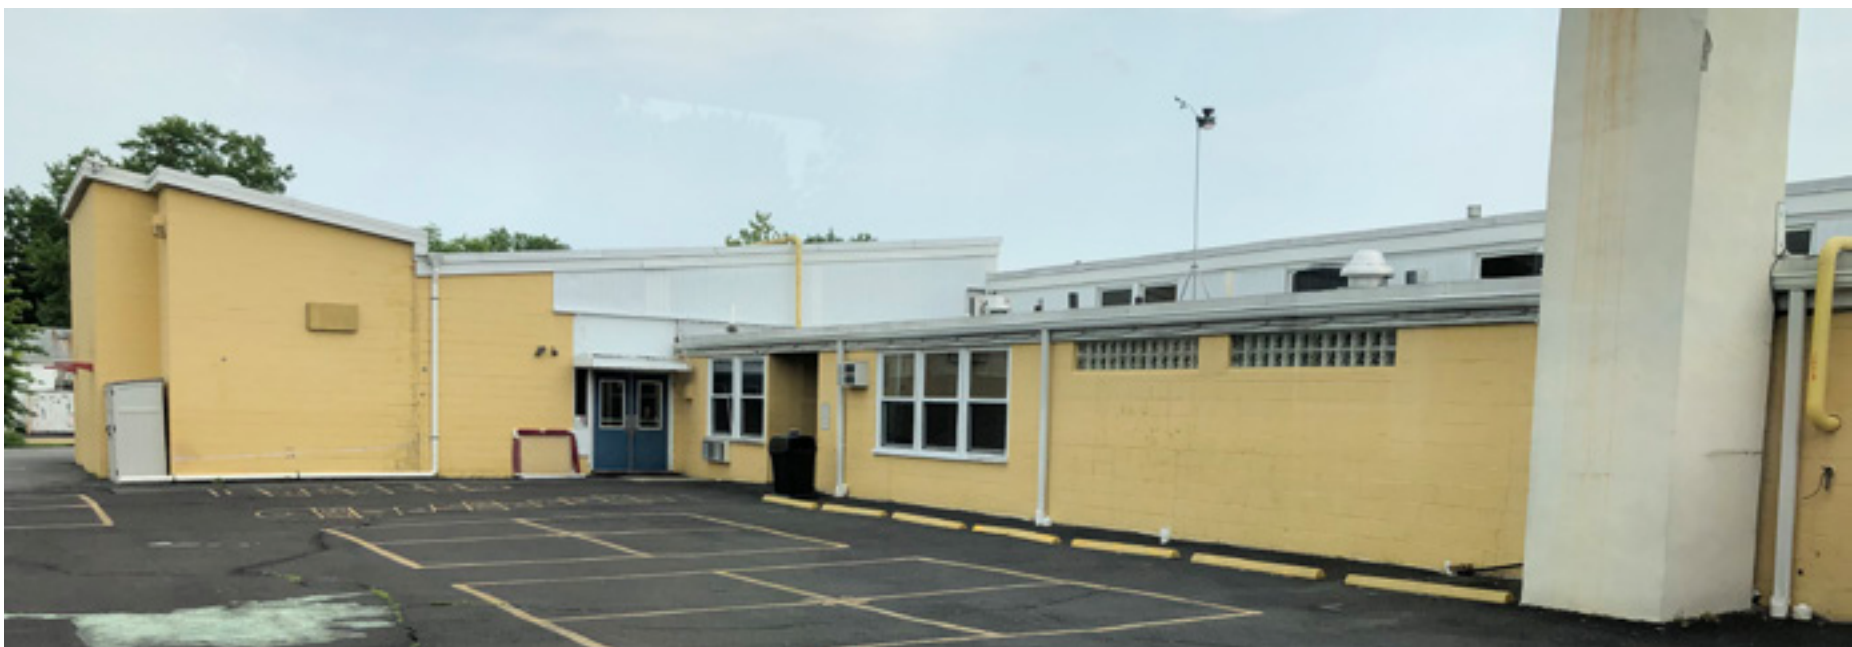
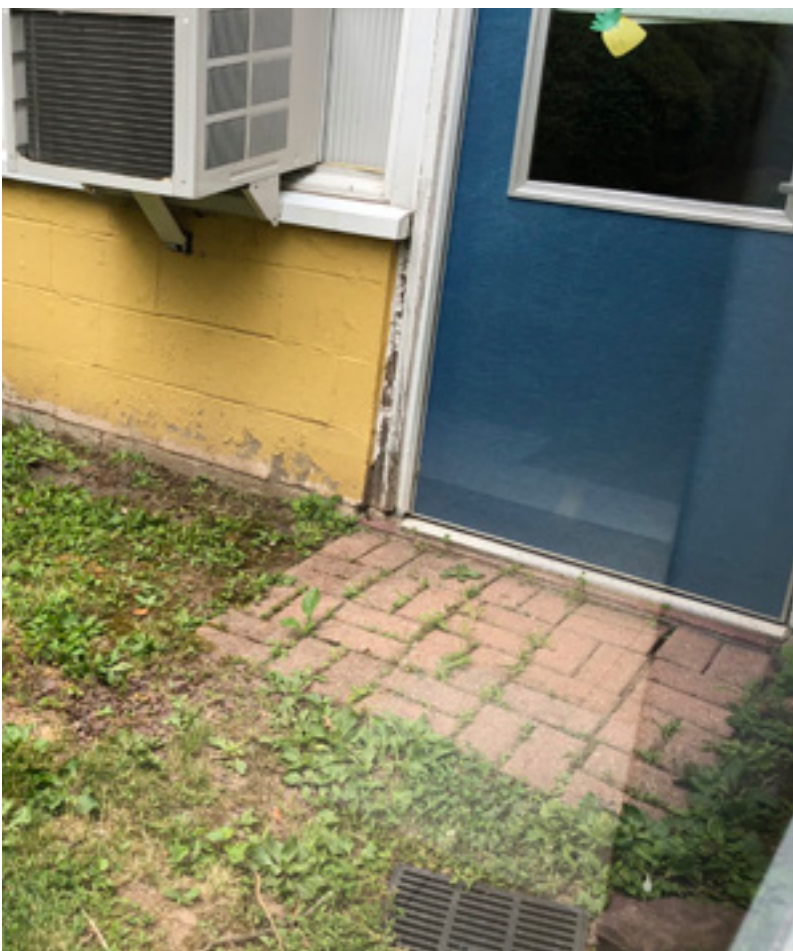
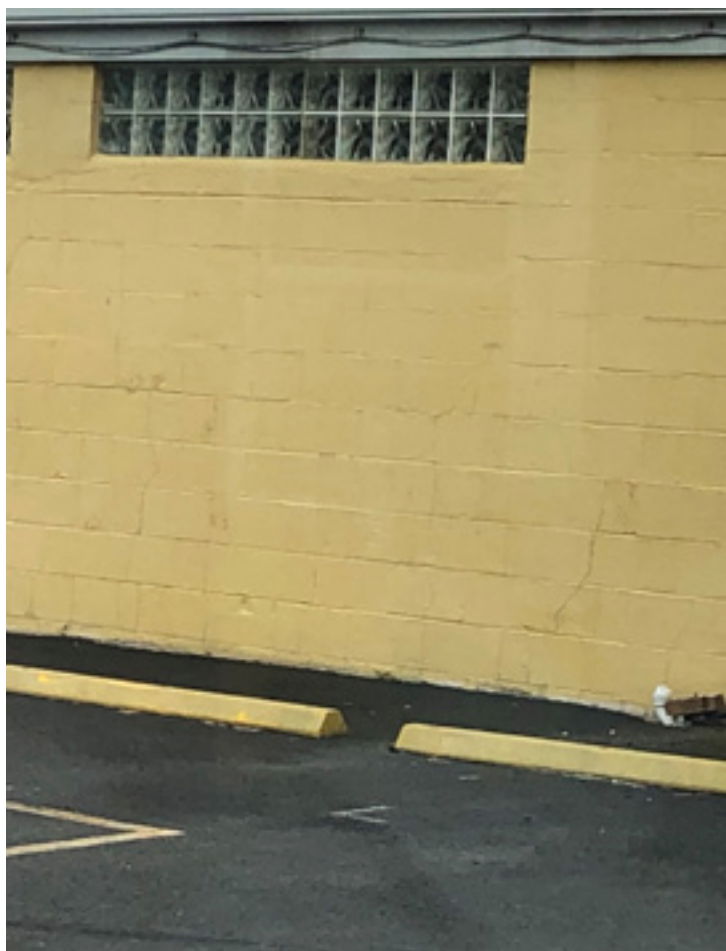
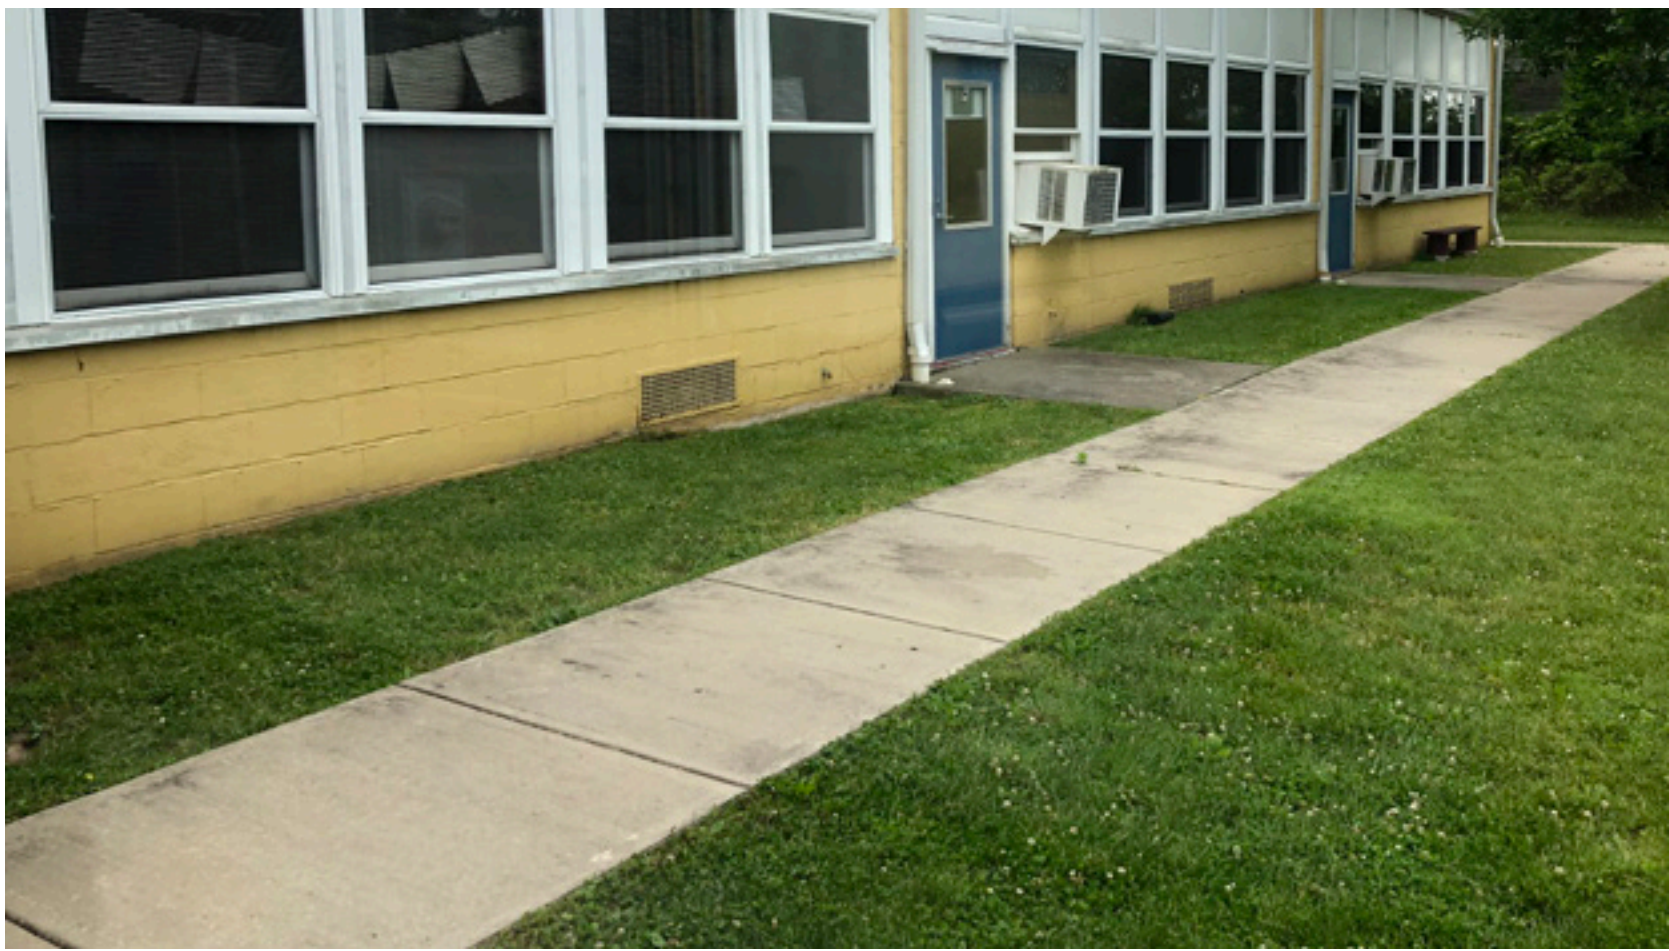
FACADE CONDITIONS

In general, West Amwell Elementary core and shell is in very poor condition. The entire façade, block and windows require improvements to the insulation barrier. The facility cannot be expanded due to existing septic fields in the rear and parking on the northern and eastern sides of the property. An upper level cannot be added to the building. The facility interior is lacking ADA requirements which creates a host of challenges with any reconstruction project. The facility is aging and in need of restoration.

INADEQUATE
BUILDING
ENVELOPE/ WALL
INSULATION

TYPICAL
CONSTRUCTION
IS SINGLE WYDTH
CONCRETE BLOCK

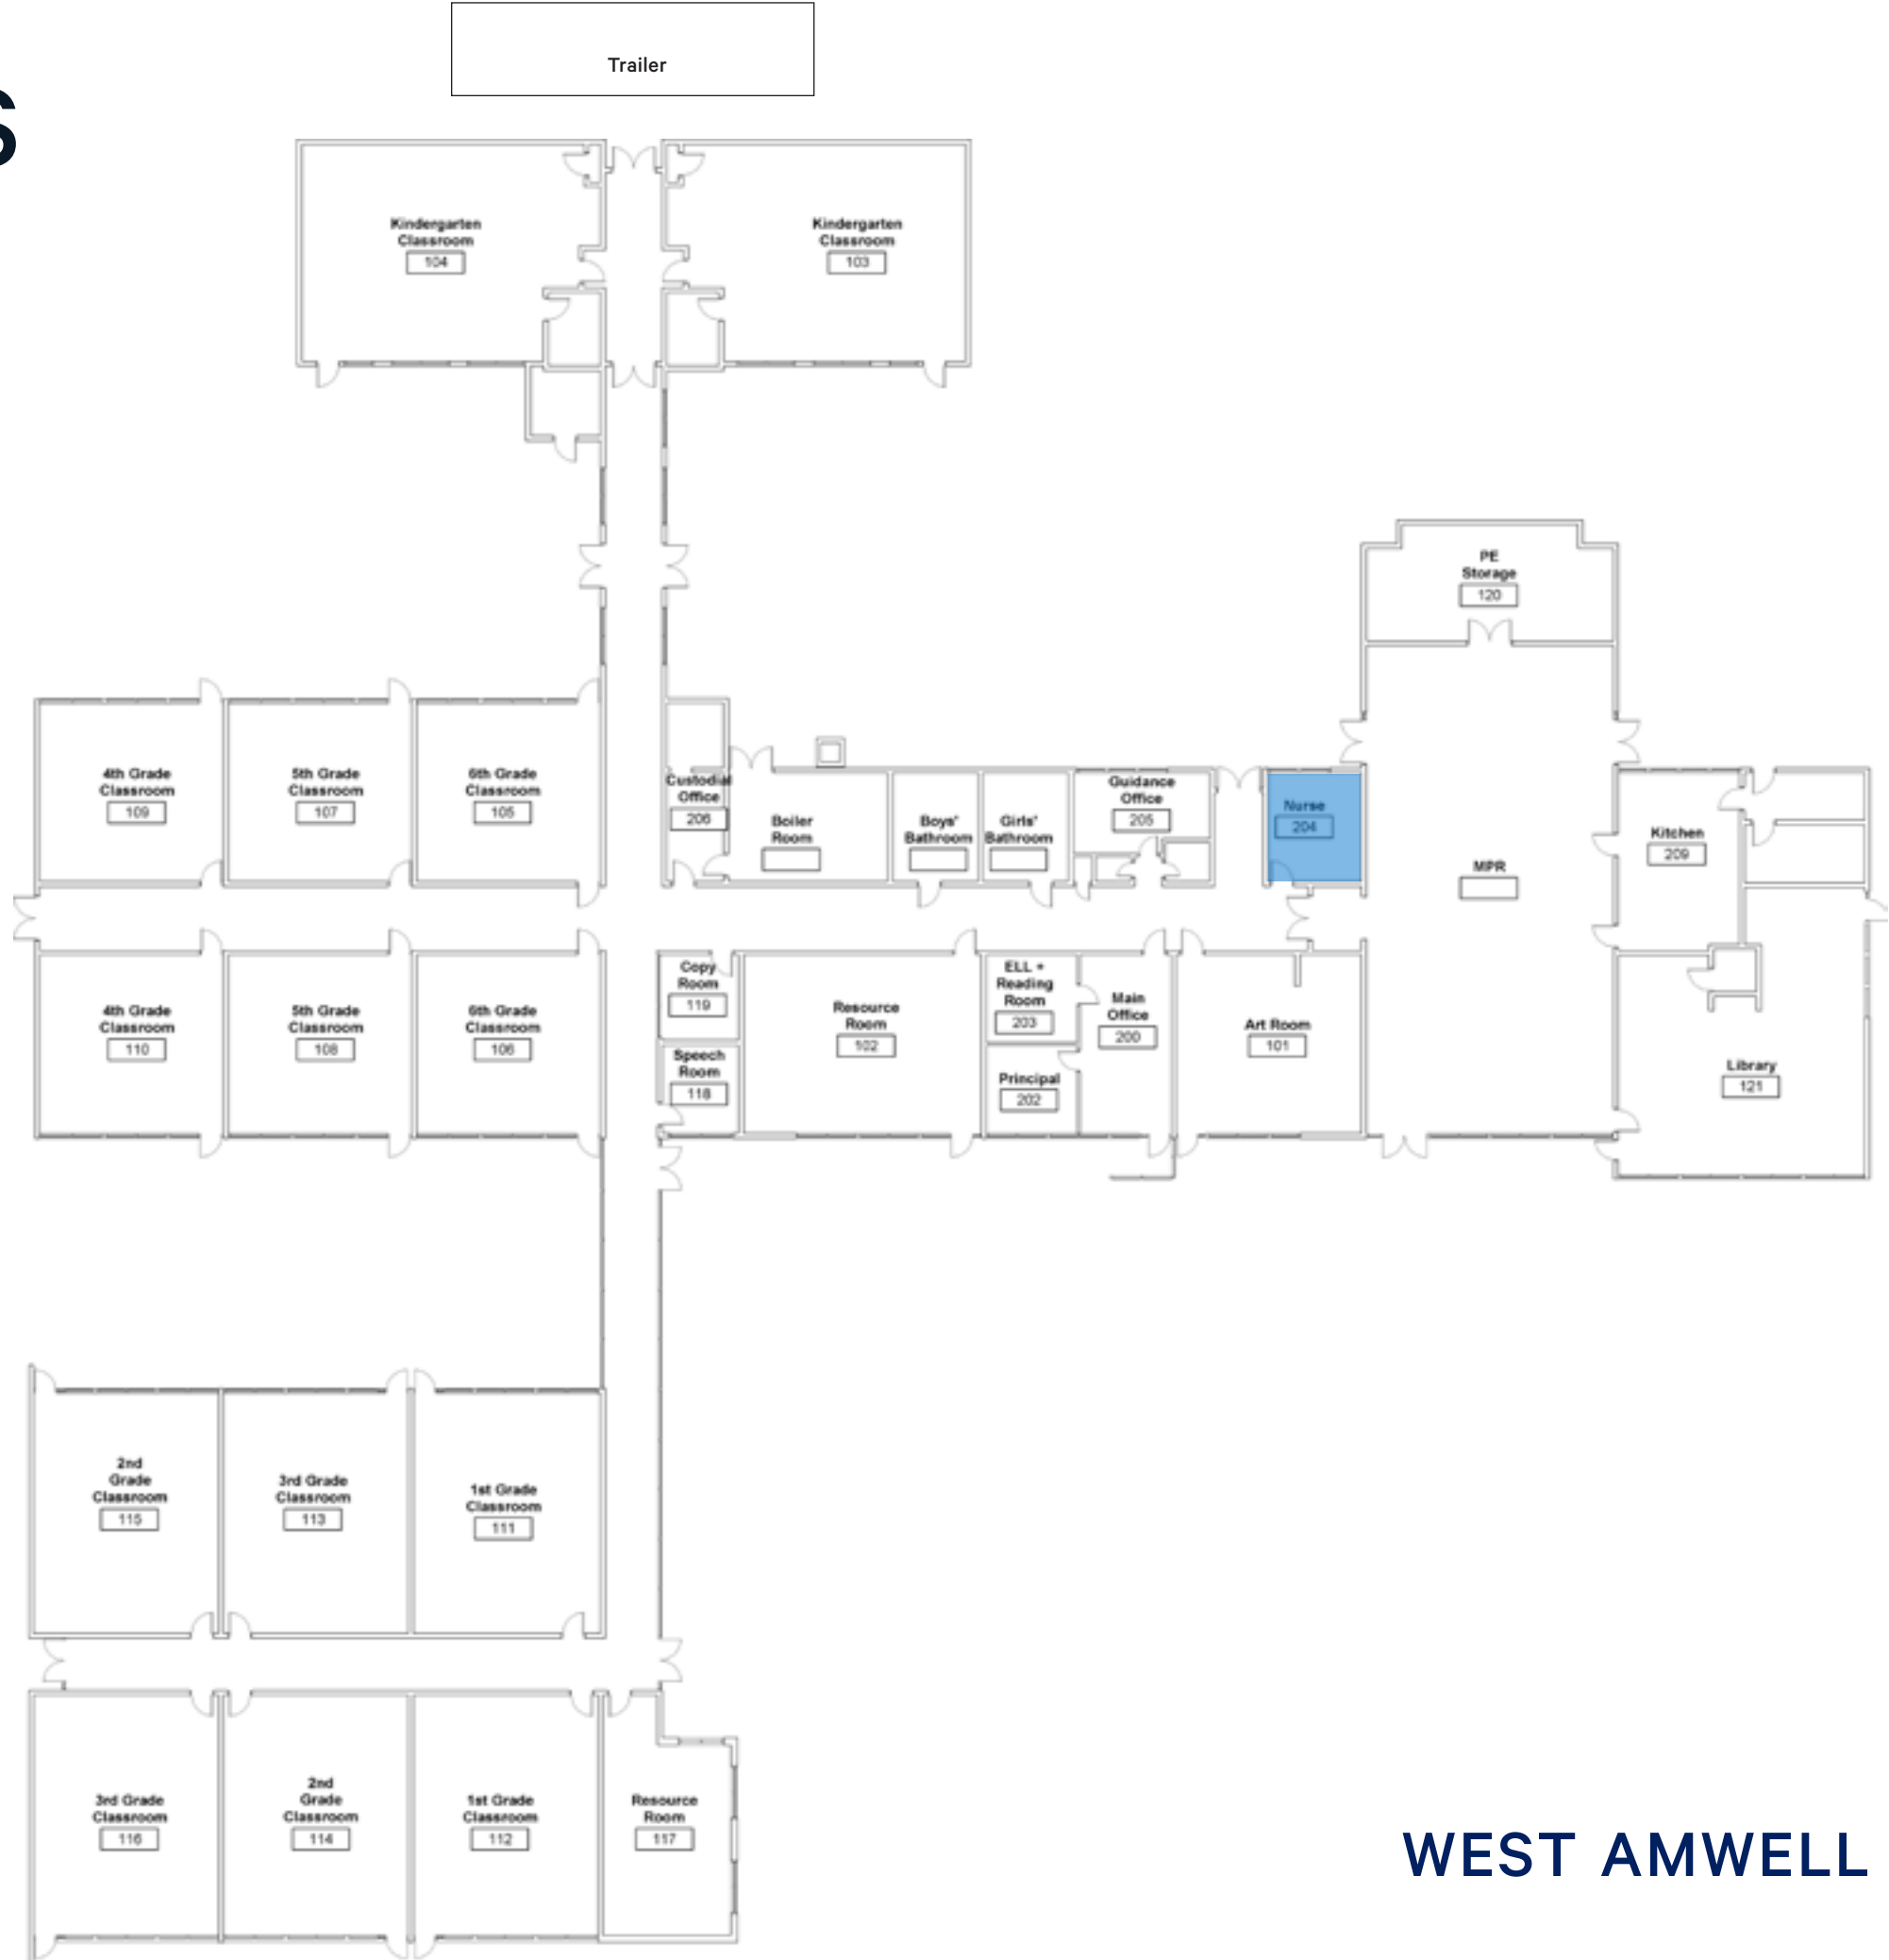
NURSE'S OFFICE

- UNIT VENTILATORS +/- 20 YRS. OLD
- PROBLEMATIC ACTUATORS
- EXISTING 600 AMP 3 PHASE SERVICE
- PROBLEMATIC/UNDERSIZED
